ELECTRICAL SAFETY FOLLOW UP INSPECTION REPORT (11TH)

Factory Name	APS Apparels Ltd.					Note:
Address	Holding No.106, Ward- 5, Baitur Rahmat, Mosque Road, E-Faidabad, Atipara, Dokhin Khan					
FACTORY ID	9438	ELECTRICAL SAFETY INSPECTION DATES				Other Factory: ----- ----- ----- ----- ----- ----- -----
Initial Inspection Date	25/03/2014	Date of 5 th Follow Up	06/09/2016	Date of 11 th Follow Up	30/01/2019	
Report Received Date		Date of 6 th Follow Up	28/11/2016	Date of 12 th Follow Up		
Date of 1 st Follow Up	05/04/2015	Date of 7 th Follow Up	09/02/2017	Date of 13 th Follow Up		
Date of 2 nd Follow Up	28/12/2015	Date of 8 th Follow Up	03/05/2017	Date of 14 th Follow Up		
Date of 3 rd Follow Up	22/03/2016	Date of 9 th Follow Up	27/08/2017	Date of 15 th Follow Up		
Date of 4 th Follow Up	28/06/2016	Date of 10 th Follow Up	02/04/2018	Date of 16 th Follow Up		
Inspected by		Mst Rebeka Sultana

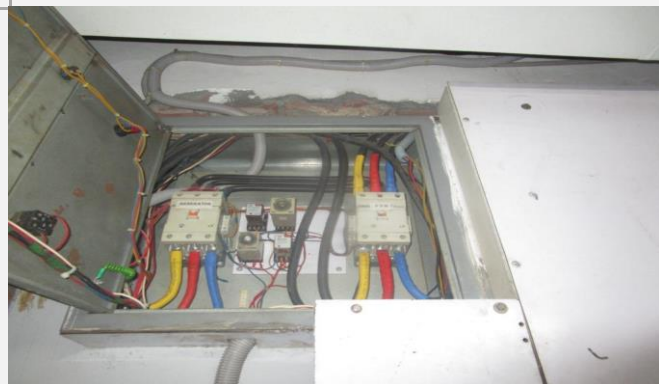
65	New Finding: Electrical power cables are not identified properly	Proper identification (by using cable marker, tag, Colored heat shrink) shall be done on major power cables used in the system according to SLD.	1 month	Factory asked for time extension till 30/09/2018. Not Accepted. On 30/01/2019: Not Corrected.	'15/05/2018	Already Corrected: Identification by using colored heat shrink already done.	In Progress
