FIRE SAFETY FOLLOW UP INSPECTION

Factory Name	APS Apparels Ltd		Accord ID	9438
Address	Holding No.106, Ward- 5, Baitur Rahmat, Mosque Road, E-Faidabad, Atipara, Dokhin Khan, Dhaka			
Inspection Date	25/03/2014		Report Received Date	
Date of 1st Follow-up	05/04/2015	Date of 2nd Follow-up	28/12/2015	
Date of 3rd Follow-up	22/03/2016	Date of 4th Follow-up	28/06/2016	
Date of 5th Follow-up	06/09/2016	Date of 6th Follow-up	28/11/2016	
Date of 7th Follow-up	09/02/2017	Date of 8th Follow-up	03/05/2017	
Date of 9th Follow-up	27/08/2017	Date of 10th Follow-up	02/04/2018	
Date of 11th Follow-up	30/01/2019	Date of 12th Follow-up		
Date of 13th Follow-up		Date of 14th Follow-up		
Inspected by	A N Faisal Ahmed

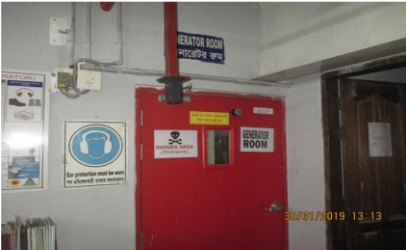
Item No	Accord Inspection Observation	Accord Action Plan (Recommendation)	Accord Timeline (given in report)	Comments from Accord (after Physical Inspection)	Final Approved Timeline (DD/MM/YYYY)	Final Action Plan (Factory)	Progress Status (on the date of Inspection)	Pictorial Evidence
1	The boiler, generator and transformer room is not separated by fire-rated construction openings, non-rated doors and penetrations on the ground floor.	Separate the boiler, generator and transformer room by a minimum 2-hr fire-rated construction. Seal and/or protected all openings to maintain the required fire separations.	Within 3 months	On 28-11-2016: Corrected. On 09/Feb/2017: Corrected. On 6th May 2017 As action plan of the factory: Corrected as per previous follow-up inspection. On 27/08/2017: Corrected. On 02/04/2018: Corrected. On 30/01/2019: Corrected.	'05/01/2016	Corrected. We have separated the boiler, generator and transformer room by fitting and fixing 2-hr fire rated door as recommended.	Corrected

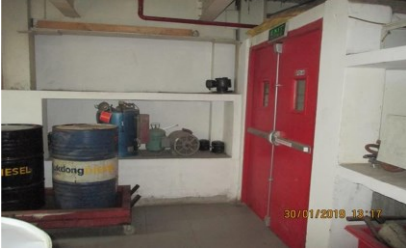
Item No	Accord Inspection Observation	Accord Action Plan (Recommendation)	Accord Timeline (given in report)	Comments from Accord (after Physical Inspection)	Final Approved Timeline (DD/MM/YYYY)	Final Action Plan (Factory)	Progress Status (on the date of Inspection)	Pictorial Evidence
6	Diesel drum area is not separated by fire-rated construction on the ground floor. Diesel drum area is opening to egress path for the ground floor.	Separate the diesel drum area by a minimum 2-hr fire-rated construction. Seal and/or protected all openings to maintain the required fire separations.	Within 3 months	On 09/Feb/2017: Corrected. On 6th May 2017 As action plan of the factory: Corrected as per previous follow-up inspection. On 27/08/2017: Corrected. On 02/04/2018: Corrected. On 30/01/2019: Corrected.	'24/12/2015	Corrected. We have created separate diesel drum storage room and protected by fire-rated construction and door. (Fire door certificate & checklist attached)	Corrected

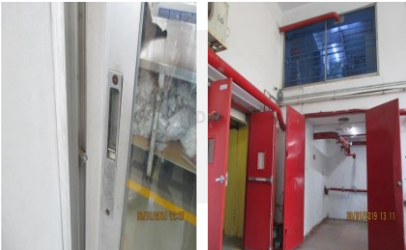
9	Collapsible doors and sliding gates are provided at the building exits, exit stairs and exit discharge.	Replace all gates / sliding doors along the means of egress with side-hinged, swinging egress doors. If locks are required for security reasons, utilize special door locking features complying with NFPA 101.	Within 1 month	On 28-11-2016: Corrected. On 09/Feb/2017: Corrected. On 6th May 2017 As action plan of the factory: Corrected as per previous follow-up inspection. On 27/08/2017: Corrected. On 02/04/2018: Corrected. On 30/01/2019: Corrected as per previous follow up. Note: Factory shall remove all kind of sliding gate at production area.	'24/12/2015	Corrected. We have removed all collapsible doors and installed fire rated/side-hinged door as suggested.	Corrected

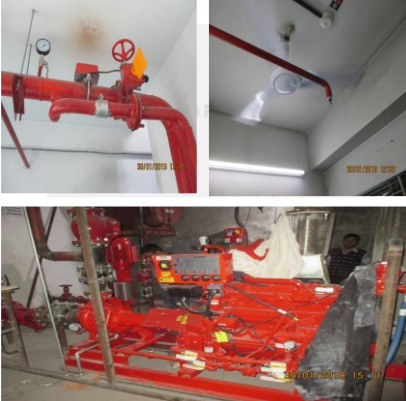
Item No	Accord Inspection Observation	Accord Action Plan (Recommendation)	Accord Timeline (given in report)	Comments from Accord (after Physical Inspection)	Final Approved Timeline (DD/MM/YYYY)	Final Action Plan (Factory)	Progress Status (on the date of Inspection)	Pictorial Evidence
10	The high-rise building has an occupied floor greater than 23m (75 ft) and is not provided with automatic sprinkler protection. The large occupant loads, heavy fuel loading, and anticipated extended egress times warrant sprinkler protection.	Provide automatic sprinkler protection throughout the building in accordance with NFPA 13.	Design within 6 months, install within 12 months	<p>On 6th May 2017 As action plan of the factory: In Progress. Installation work is going on.</p> <p>On updated CAP for the month of July, 2017 factory committed to complete the remediation work within 31st Aug, 2017 but time extension are not accepted. Remediation work should be completed as per Accord approved timeline.</p> <p>On 27/08/2017: Installation is going on.</p> <p>On 02/04/2018: Progress is not satisfactory. No significant progress was observed since last follow-up. Piping work still not completed yet. Moreover, procurement of the required fire pumps hasn't been finalized yet.</p> <p>Factory asked for time extension till 30/12/2018. Not accepted.</p> <p>On 30/01/2019: Fire pump installation is going on. Non listed valve was observed. Fire pump room shall separate properly from adjacent store area. Installation shall meet NFPA 13, 14, 20 & Accord standard.</p>	'31/10/2016	<p>We have a nonlisted pumps which has been procured in 2014. the pump set not finally installed due to this issue.</p> <p>Recently we decided to procure another pump listed pump set. We have already issued L/C in May 24, 2018. Estimated time of arrival (ETA) of the fire pump is Nov 27, 2018. we will completed the issue within Dec 31, 2018. the pipeline works has been already done</p>	In Progress

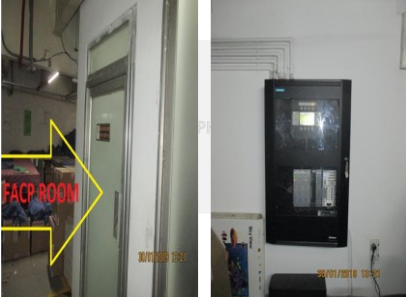
11	The fire alarm system is antiquated, not a listed system, and does not provide alarm and notification features consistent with acceptable standards.	Replace the fire alarm system with a new, listed addressable fire alarm system in accordance with NFPA 72.	Within 3 months	<p>On 09/Feb/2017: Installation work is ongoing.</p> <p>On 6th May 2017 As action plan of the factory: In Progress. Installation work is going on.</p> <p>On 27/08/2017: Installation is going on.</p> <p>On 02/04/2018: Installation has not been completed yet.</p> <p>Factory asked for time extension till May 2018. Not accepted.</p> <p>On 30/01/2019: Reportedly, installation is complete & waiting for completion of protection system to apply for T&C VI. However, it was advised, if commissioning of the fire alarm system being complete, factory can apply for T&C VI. FACP shall install on a isolated fire separated safe room.</p>	'31/10/2016	Corrected	In Progress

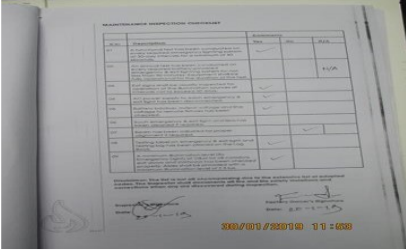
Item No	Accord Inspection Observation	Accord Action Plan (Recommendation)	Accord Timeline (given in report)	Comments from Accord (after Physical Inspection)	Final Approved Timeline (DD/MM/YYYY)	Final Action Plan (Factory)	Progress Status (on the date of Inspection)	Pictorial Evidence
13	Inspection, testing, and maintenance for the emergency lighting system was not in accordance with The ACCORD standard.	Inspect, test and maintain the emergency lighting system in accordance with The ACCORD standard. Keep written records on-site.	Within 3 months	On 09/Feb/2017: Corrected. On 6th May 2017 As action plan of the factory: Corrected as per previous follow-up inspection. On 27/08/2017: Corrected. On 02/04/2018: Corrected. On 30/01/2019: Corrected.	'02/09/2015	Corrected. We have started to inspect, test and maintain the emergency lighting system in accordance with The ACCORD standard & keeping written records.	Corrected

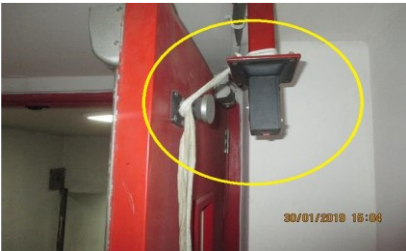
14	New Finding: Store room in the basement floor, roof floor is not separated from exit stair and store room in the ground floor is not separated from medical center, childcare, offices by fire rated construction.	Separate the store rooms by a minimum 1-hr fire-rated construction. Seal and/or protected all openings to maintain the required fire separations.	Within 3 months	On 6th May 2017 As action plan of the factory: Corrected. On 27/08/2017: Corrected. On 02/04/2018: Not completed yet. Factory asked for time extension till 30/09/2018. Not accepted. On 30/01/2019: Not corrected yet. Fire door was kept open by external source ,	'31/10/2016	Already Corrected.	In Progress

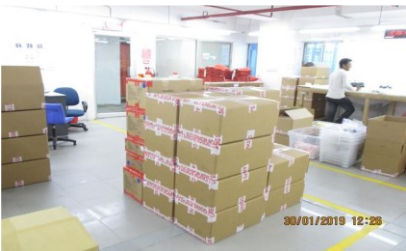
15	New Finding: Areas used for combustible storage in the sixth floor is not separated by fire-rated construction.	Provide dedicated storage rooms separated by minimum 1-hr fire-rated construction. Where separate storage rooms are not feasible, provide defined storage areas and limit the storage arrangement as follows:- Maximum height of 2.4m and maximum area of 23m ² - If sprinkler protected: maximum height of 3.66m and maximum area of 93m ² Separate areas of unenclosed combustible storage by a minimum clear distance of 3m.	Within 3 months	On 28-11-2016: Corrected. On 09/Feb/2017: Corrected. Pile dimension area is maintaining. On 6th May 2017 As action plan of the factory: Corrected as per previous follow-up inspection. On 27/08/2017: Corrected. On 02/04/2018: Corrected. On 30/01/2019: Corrected.	'25/04/2016	Corrected. We have provided defined storage area as per given suggestion. Now we don't use different area for combustible storage. Also note that, we have completed the installation of fire door at mentioned floor. We are also going to install hydrant/sprinkler	Corrected

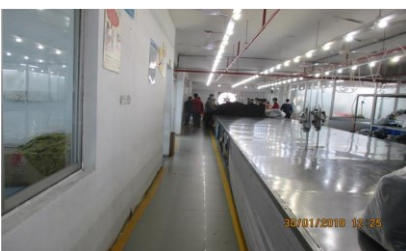
16	New Finding: The width of aisle is less than 36 inch. In the mezzanine floor store room, fifth floor's cutting section.	Provide a minimum aisle width of 36 inch.	Within 1 month	On 28-11-2016: Corrected. On 09/Feb/2017: Corrected. On 6th May 2017 As action plan of the factory: Corrected as per previous follow-up inspection. On 27/08/2017: Corrected. On 02/04/2018: Not corrected. Found improper during follow-up inspection period. Aisles width at 6th floor has found inadequate. Issue is re-opened. On 30/01/2019: Corrected.	'20/07/2016	Already Corrected.	Corrected

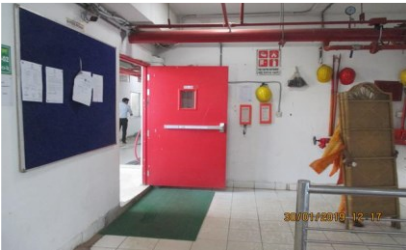
18	New Finding: Exit stair door / egress door serving 50 or more occupants does not swing in the direction of egress travel in the ground and roof floor.	Modify the egress door to swing in the direction of egress travel.	Within 1 months	On 09/Feb/2017: Corrected. On 6th May 2017 As action plan of the factory: Corrected as per previous follow-up inspection. On 27/08/2017: Corrected. On 02/04/2018: Corrected. On 30/01/2019: Corrected.	'31/10/2016	Corrected. we have complete the work as suggested.	Corrected

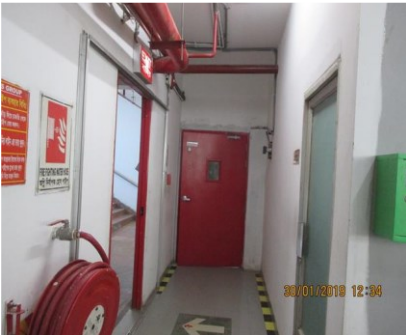
19	New Finding: Office area in fifth floor and kitchen in sixth floor are not separated from adjacent cutting area by fire rated construction.	Provide minimum 1.5-hr fire rated doors and seal all unprotected openings to separate the exit stairs from work areas and other building spaces on all floor levels. Ensure that the fire doors are self-closing and positive latching and that they are provided with fire exit (panic) hardware where serving production floors. If fire doors are required to be held open for functional reasons, provide automatic-closing devices tied to the fire alarm system.	Within 3 months	On 28-11-2016: Partially corrected. Kitchen has been removed from sixth floor. Office area is not separated from the production area in fifth floor. On 09/Feb/2017: No action has been taken yet. On 6th May 2017 As action plan of the factory: In Progress. It has found same as it was before follow-up inspection. On 27/08/2017: Corrected. On 02/04/2018: Not corrected. Found improper. Fifth floor office area has found not fire separated as per recommendation. Issue is re-opened. On 30/01/2019: Office area is separated by fire door.	'31/10/2016	Already Corrected.	Corrected

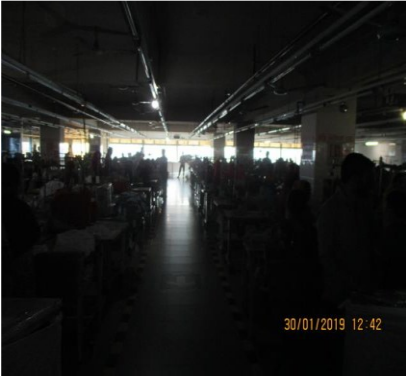
Item No	Accord Inspection Observation	Accord Action Plan (Recommendation)	Accord Timeline (given in report)	Comments from Accord (after Physical Inspection)	Final Approved Timeline (DD/MM/YYYY)	Final Action Plan (Factory)	Progress Status (on the date of Inspection)	Pictorial Evidence
20	New Finding: Based on the number and location of emergency lights observed, adequate illumination levels are not anticipated along egress routes. It has been observed throughout the building.	Test the emergency lighting system on each floor and provide additional emergency fixtures to provide adequate illumination along the means of egress. Provide a minimum illumination of 10 lux at the floor level within exit stairs and exit discharge paths and minimum 2.5 lux along exit access aisles.	Within 1 months	On 28-11-2016: Corrected. On 09/Feb/2017: Corrected. On 6th May 2017 As action plan of the factory: Corrected as per previous follow-up inspection. On 27/08/2017: Corrected. On 02/04/2018: Not corrected. Found improper. Inadequate illumination levels of emergency lightings units were observed during follow-up inspection period. Factory shall ensure adequate illumination levels along the egress routes as per recommendation where required. Issue is re-opened. On 30/01/2019: Not corrected. Found improper. Inadequate illumination levels of emergency lightings units were observed at floors.	'20/07/2016	Corrected. We have provided some additional emergency fixtures to ensure minimum illumination.	In Progress

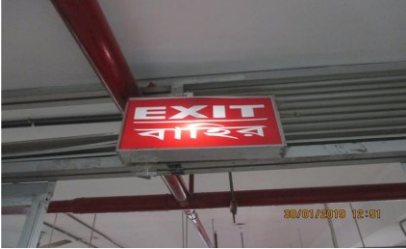
21	New Finding: Manual on-off switch is provided for emergency lighting units.	Remove manual on/off switches from emergency lighting units to prevent them from being switched off.	Within 1 month	On 09/Feb/2017: Corrected. On 6th May 2017 As action plan of the factory: Corrected as per previous follow-up inspection. On 27/08/2017: Corrected. On 02/04/2018: Corrected. On 30/01/2019: Corrected.	'29/12/2015	Corrected. We have removed manual on/off switch from mentioned emergency lighting unit.	Corrected
